CPP Oil Distributor Shaft Repair

Categories:	Marine Parts Recovery by Laser Cladding
Date:	Mai 2016.
Project Object:	Passenger Ship CPP Oil Distributor Shaft
Project Description:	Repair of the neck, diameter 530 mm, worn out of limits
Repair Place:	Reneko workshop
Repair Time:	3 days
Class Survey:	BV
Warranty:	Yes, standard service warranty apply

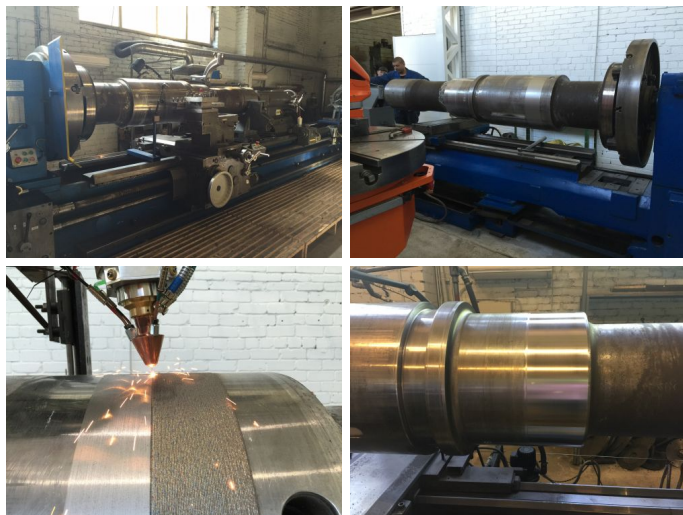
CPP oil distributor shaft was found in unacceptable condition due to excessive wear of the neck.
Reneko submitted repair procedure to the Class, prior to repair.
Repair was done in Reneko workshop, by laser cladding method.
All repair process, including final machining has taken 3 working days.
Work was accepted by Customer and Class without remarks.
