Fixed Pitch Propeller, diameter 5500 mm, voyage repair

Project details			
Categories:	Voyage Repairs of Propellers		
Date:	Aug. 2014.		
Project Object:	FPP, bronze, diameter 5500 mm, damaged		
Project Description:	2 blades voyage welding repair with NEW tips installation		
Repair Place:	Riga Shipyard		
Repair Time:	6 days		
Class Survey:	RINA		
Factory Warranty:	Standard service warranty

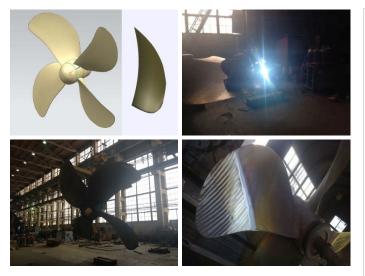
Propeller was damaged by ice with 2 blades bent under app. 90 degrees. Reneko voyage team performed propeller repair in Shipyard workshop. NEW tips, 2 pcs, CAD modelled upon 2D drawing, casted in Cu3 alloy were prepared. Repair was done under supervision of RINA Class. Repair was made inclusive: Post Weld Heat Treatment, post-repair geometry and pitch measurements, propeller balancing, penetrant test.
