MAK 43C, Cylinder Cover Reco

Categories:	4-stroke motors Cylinder Covers
Date:	Aug 2017.
Project Object:	MAK 43C Cylinder Cover
Project Description:	Cylinder Cover sealing belt and exhaust valve pocket Reco
Repair Place:	Reneko workshop
Repair Time:	app 2 Weeks
Warranty:	Standard service warranty

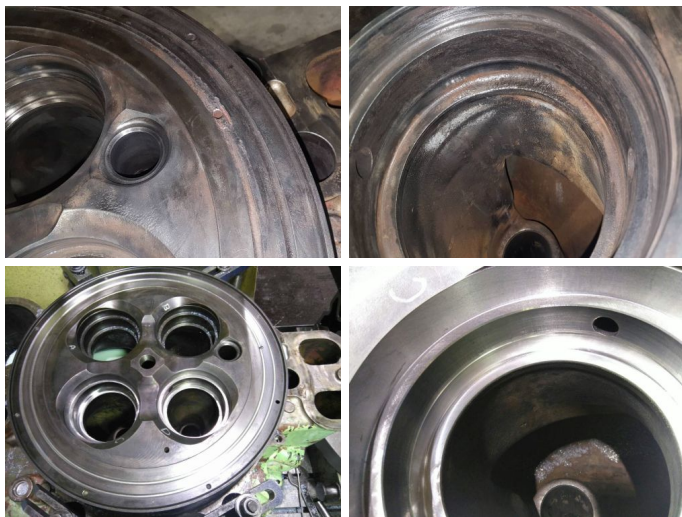
- sealing belt behind landing collar is partially destroyed in operation.
- valve guide bore had damage on the surface

Reneko made Ultrasonic cleaning, visual and geometrical inspection and found one another problem: exhaust seat pocket "C" upper sealing diameter is also partially destroyed by corrosion (deep groove abt 3 mm in depth)

Sealing belt behind landing collar: Corroded area was machined-off. Belt was rebuilt to original size.
Exhaust valve pocket upper sealing diameter: Corroded area repaired, clad by corrosion resistant Ni-alloy.

Both exhaust pockets were machined to 1-st oversize to improve the quality of the pockets.

Valve guide bore was machined to oversize with OZ valve guide installation.
