## Skewed CPP blade 3500 kg, stainless ICE-Class welding repair

Categories:	Repair of CPP Blades
Date:	Oct 2016.
Project Object:	Passenger ferry ICE Class stainless steel CPP blade, skewed, 3500 kg.
Project Description:	Damaged CPP blade, stainless, welding repair and excessive wear on flange repair.
Repair Place:	Reneko workshop
Repair Time:	1 Week
Warranty:	Standard service warranty was provided.

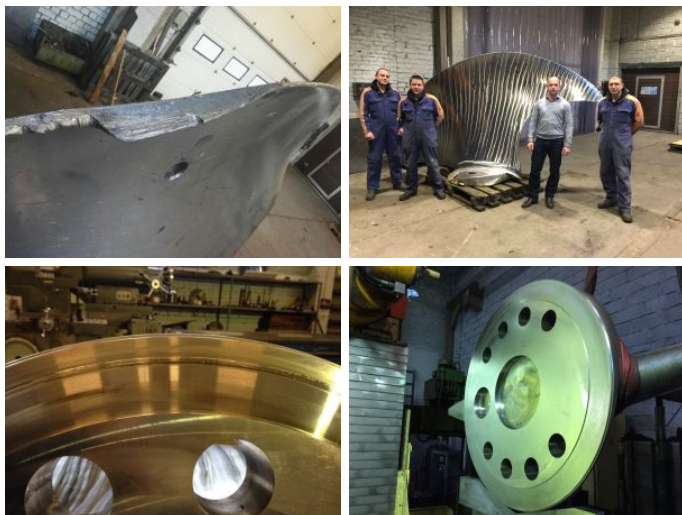
ICE Class stainless steel CPP blade was damaged by ice, during the winter navigation in Baltic Sea. When disassembled there was additionally found an excessive wear in place of O-ring seal, on the flange.

Ice damage was welding repaired by following a Class-approved procedure, also a special Post Weld Heat Treatment was done, obligatory required for Cr-stainless steels for the purpose of repair stresses relief and metal structure improvement in welding and Heat Affected Zones area.

CPP blade flange was subjected to repair machining, in order to eliminate wear on O-belt under O-ring seal.
