Turbocharger KBB R5-3 Rotor Shaft Repair

Project details

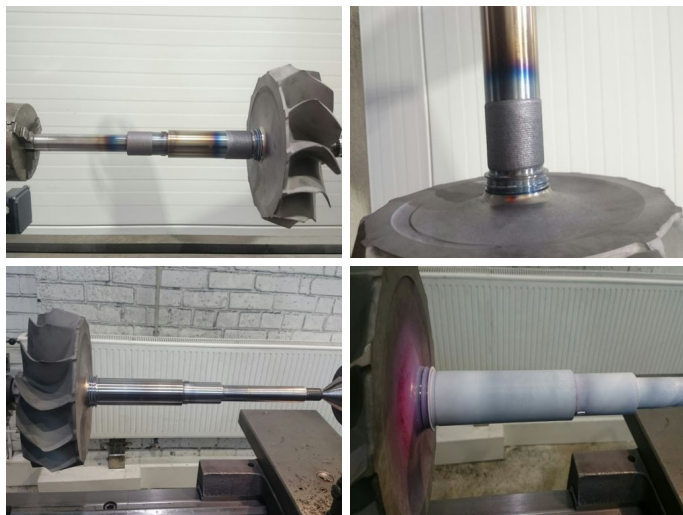
Categories:	Turbocharger Rotors
Date:	Dec. 2016.
Project Object:	Turbocharger KBB R5-3 Rotor Shaft
Project Description:	Repair of 2 pcs bearing necks, wore out of limits
Repair Place:	Reneko workshop
Repair Time:	3 days
Warranty:	Standard service warranty apply

Turbocharger rotor shaft necks were repaired by laser cladding method, without any shaft deformations. Necks original hardness was measured before repair and saved on the design level after repair. Shaft jumping was carefully checked and recorded, no changes has been observed after repair process.
