CPP Mechanism Repair

Categories:	CPP Components Repair in Assembly
Date:	Jan 2016.
Project Object:	Passenger Ship Thruster CPP Mechanism Repair
Project Description:	Repair of Worn Components of CPP Mechanism during Ship DD
Repair Place:	Reneko Workshop
Repair Time:	5 days
Warranty:	Service warranty provided.

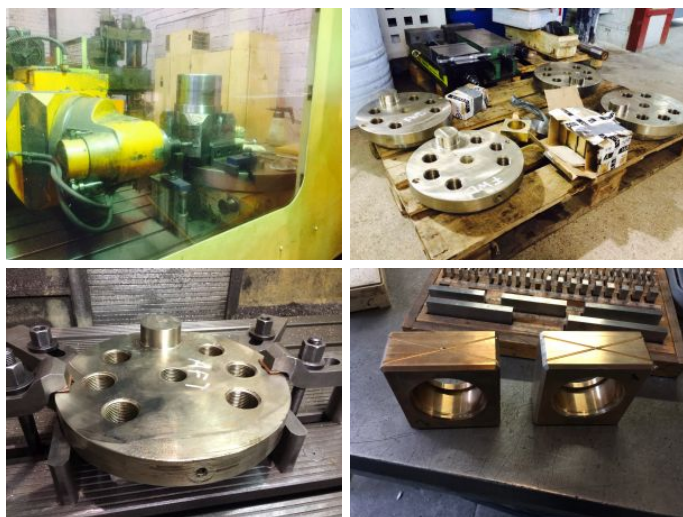
Thruster CPP was serviced during Passenger Ship DD. There was found an excessive wear of main CPP components: CPP Blades flanges, CPP Slider grooves, CPP Bronze Sliding Blocks, CPP Discs. All parts were delivered to Reneko workshop for repair.

Repair was done by mean of high precision CNC machining.

Repair has taken 5 days in total.

Thruster was succesfully assembled and installed back to the Ship. At present article moment (May 2017.) still in operation without known problems.
