## MAK 25 Cylinder Covers lower O-belt Reco

Categories:	4-stroke motors Cylinder Covers
Date:	Dec-2016.
Project Object:	ME MAK 25 Cylinder Covers 8 pcs
Project Description:	Cylinder Covers, all 8 pcs, had corrosion wear in place of lower O-ring seal
Repair Place:	Reneko workshop
Repair Time:	1 Week
Warranty:	Yes

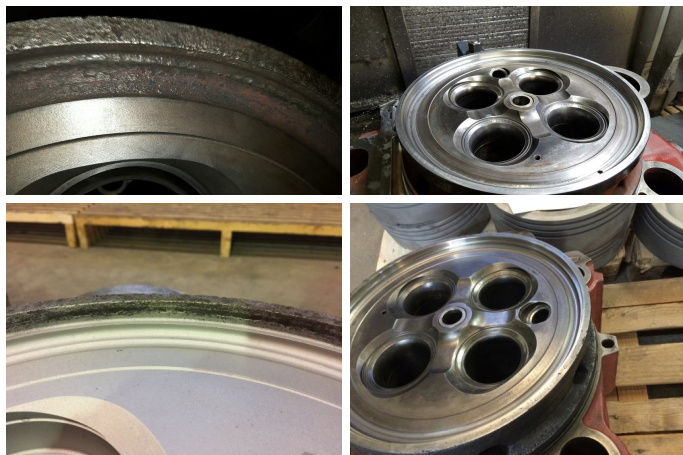
ME MAK 25 cylinder covers were subjected NO-GO for the further use because of critical corrosion wear in place of lower O-belt. Replacement or Reco was required to complete engine overhaul. Ship Management has chosen Reco instead of replacement as a cost-effective solution. Reco was done in Reneko workshop. Corrosion was eliminated completely by pre-machining and, after that, a new corrosion-resistant material was applied. Post-machining was done to original design shape.

Cylinder covers, all 8 pcs, were installed back to the engine immediately after repair. Currently in operation.
