Yanmar N21-A2 Cylinder Covers, 2 pcs, exhaust pockets Reco

Categories:	4-stroke motors Cylinder Covers
Date:	Nov 2016.
Project Object:	Yanmar N21-A2 Cylinder Cover, 2 pcs
Project Description:	Reco of exhaust pockets, worn out of limits
Repair Place:	Reneko workshop
Repair Time:	1 Week
Warranty:	Yes, standard service warranty apply.

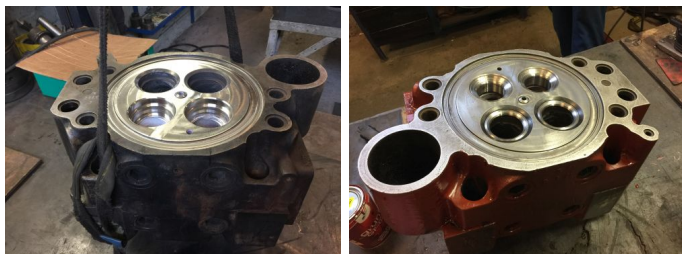
Cylinder covers, 2 pcs, was found in NO-GO condition in place of exhaust pockets.

Exhaust pockets were touched by corrosion and out of dimensional tolerance.

Reneko performed Reco of exhaust pockets to original size.

After that, cylinder cover was overhauled with NEW parts: central sleeve, valve guides, valve seats, and delivered back to the Customer
