Yanmar N260 Cylinder Covers, 4 pcs Reco

Categories:	4-stroke motors Cylinder Covers
Date:	June 2017.
Project Object:	Yanmar N260 Cylinder Cover, 4 pcs
Project Description:	Exhaust valve seat pockets Reco
Repair Place:	Reneko workshop
Repair Time:	app 1 Month
Warranty:	Standard service warranty

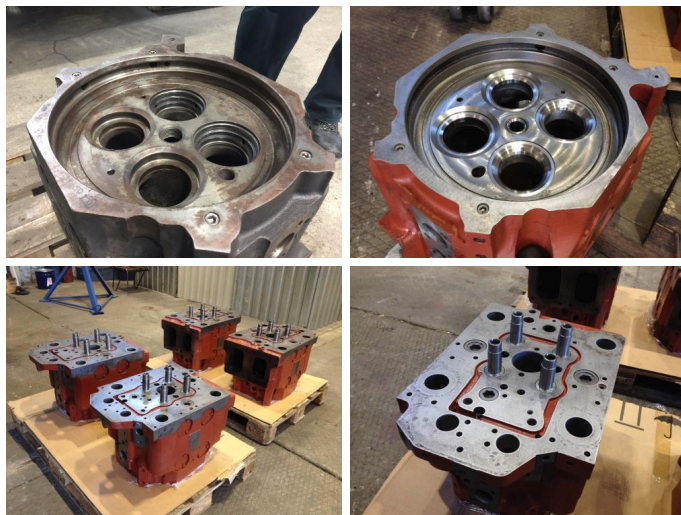
The problem was in exhaust valve seat pockets – corrosion wear out of tolerance with following leak through the seats.

At first cylinder covers were Ultrasonic cleaned, visually and geometrically inspected.

Exhaust valve seat pockets were reconditioned to original size, plated by corrosion resistant Ni-alloy.

Cylinder covers were assembled, pressure tested, painted and delivered back to the Customer.
